## Looking for Mr. Goodcar

What do experienced eyes look at during a pre-purchase inspection?  
Jeff Glenn learns how the pros do the job on an early C3.

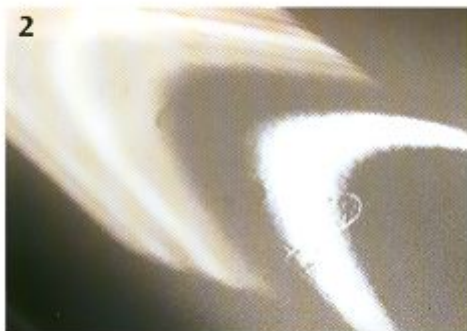
weren't visible in regular sunlight, including two spots on the side of the hood blister probably caused by drips from the painter's spray gun (*photo 2*). They'd been properly buffed and levelled, so they wouldn't be an issue on any kind of street car. For a top-level showcar, it would've been more of a problem.

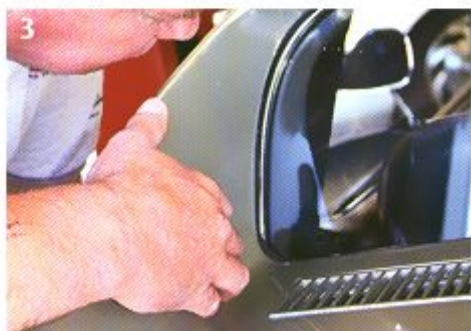
**C:** Another spot that's notoriously tricky to paint on early C3 coupes is the curved area around the backlight (*photo 3*). In resprays this section is frequently missed, so it ends up feeling dimply and rough.

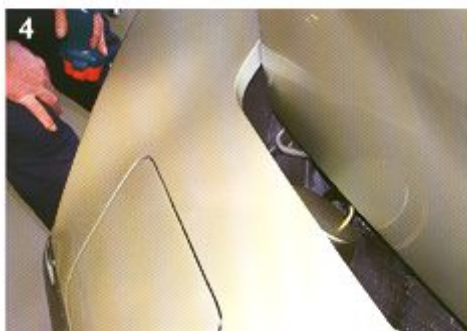
At the nose, look for signs of rivets just in front of the leading edge of the hood; there's a steel header bar under there, and imperfect repairs often let the rivet heads show through (*photo 4*). The same rivets are also susceptible to rust, which shows up as cracks or subsurface dimpling. Pat found evidence of slight patchwork on one front corner, but felt that "Unless this was represented as a 100-point showcar, I wouldn't be alarmed by anything that minor."

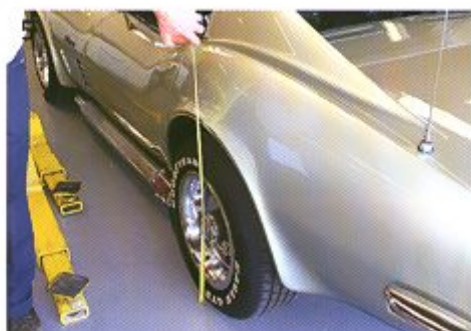
**D:** Scoping out the car's stance, Pat said "It's maybe a bit high in the back, probably thanks to heavy-duty springs." After checking the tire pressures to be sure they were even, he took out a tape measure and verified the distance from the ground to each fender lip (*photo 5*)—a surefire way to detect tired springs. The car sat a tad lower on the driver's side than the passenger's side—not unusual given less-than-brand-new springs—but it was close enough.

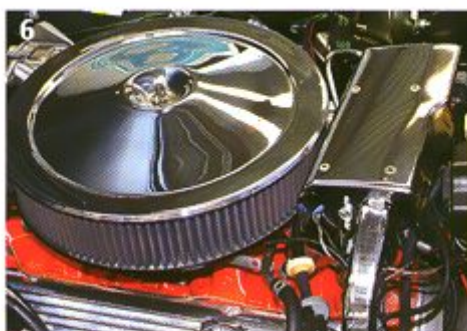
**E:** Upon popping the hood, Pat pointed out a cockeyed distributor shield (*photo 6*). "Very common; it's easy to mix up the brackets that bolt to the manifold, and putting one on the first time is always trial-and-error." He took

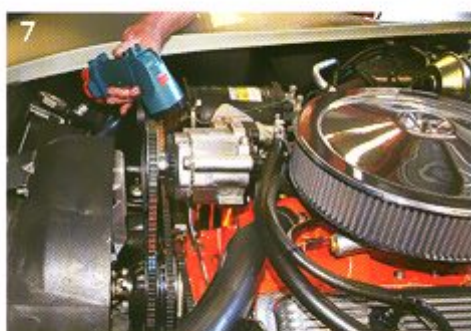
At the front of the engine, the next revealing inspection involved belt alignment. First Pat checked the clearance between the lower radiator hose and the drive belt. Chevy used a bracket to act as a shield here, but on a neglected car the belt often works free and starts cutting the hose. "These cars are also notorious for having the air-pump and power-steering pumps askew—I'm constantly modifying the brackets to get them straight. On this car, the alignment (*photo 7*) is fantastic."

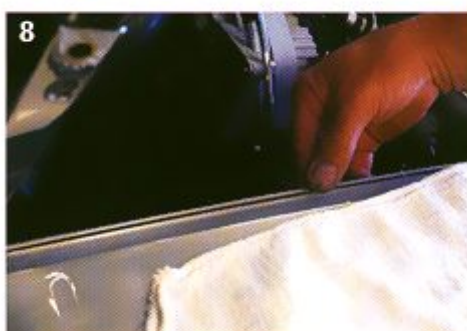
The engine-compartment lip was checked for damage or cracking next (*photo 8*), especially at the junction where it meets the fender. Cars that have been hit can show signs of hasty repairs in these areas. If the surfaces are smooth and you don't find anything rough or bumpy, it's okay to move on.

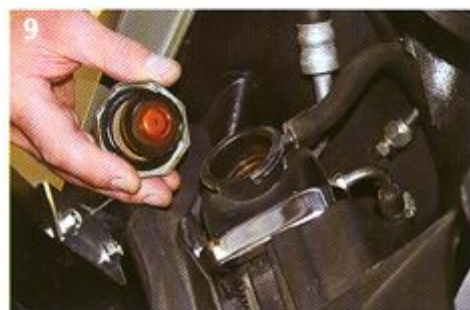
**F:** The next step was to pop off the radiator cap and inspect the coolant (*photo 9*). You want to see fairly clean fluid with no rust and no signs of foaming or milky discoloration (indicating a blown headgasket or worse). Pat likes to take a quick sniff of the cap, too, just to see if he smells any combustion gasses. If he does, he'll take an old-style exhaust-gas analyzer and use it to double-check for hydrocarbons. Bonnie's '72 was due for a coolant flush, but showed no sign of major issues.

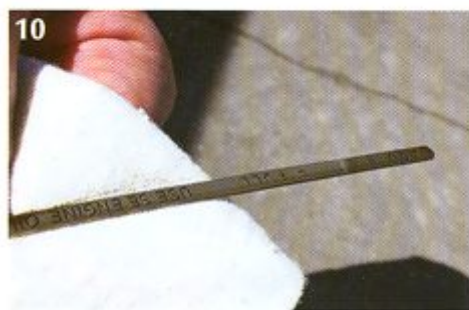
**G:** Moving along under the hood, he pulled out the dipstick *without wiping it* and held it up in the sun to assess the oil—whether it was dirty, clean, or (in this case) even there at all (*photo 10*). With no fluid on the stick, this car was a minimum of two quarts low. Two quarts later, the level in this engine was right on the money, and what was already in there seemed clean. "I always check that because later, out on a test drive, I'd have the throttle on the floor and not enough oil in the sump." Pat made a mental note to check for any indication of oil-burning or leakage later in the inspection—as it happened, he didn't find any.

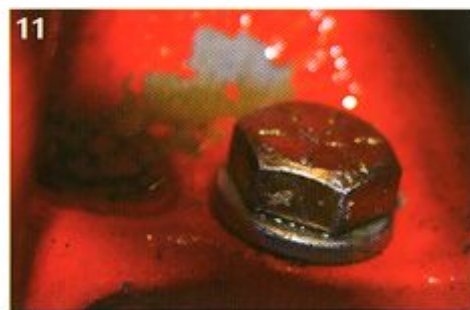
**H:** Looking around the intake manifold for puddles of anything that shouldn't be there, he noticed a blob of coolant in a crevice near the thermostat housing (*photo 11*). From the location, Pat felt it was probably due to a seeping thermostat housing or an imperfect heater hose; in either case, a very minor fix.

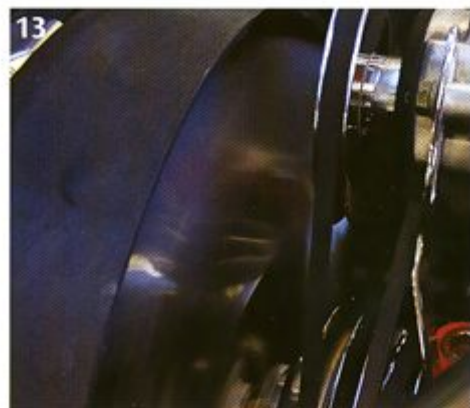
**K:** During the brief warmup and cranking test, Hendrix observed that the fan kept spinning long after the engine was stopped (*photo 13*). "That means that the fan clutch isn't working well; we'll have to keep an eye on the temp on the test drive."

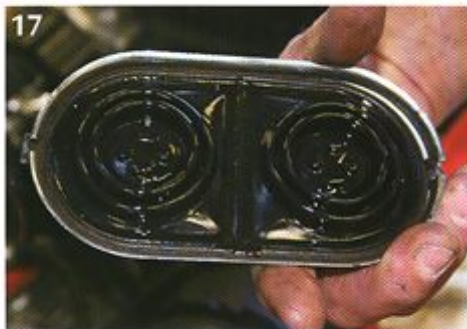
**M:** The last key reservoir is the brake master. After undoing the bails so as not scratch the chrome cap, Pat carefully lifted the top and peered in (*photo 16*). You're again looking mostly for level and color. Clear, clearish-yellow, or even translucent-brown fluid is normal. If the fluid is opaque brown or black, it at best needs a flush. At worst, you may be facing a costly hydraulic rebuild. Another trick is to look at the expandable rubber boots in the bottom of the reservoir cap. Most people don't return these to the proper collapsed position (*photo 17*), which indicates less-than-zealous knowledge and attention.

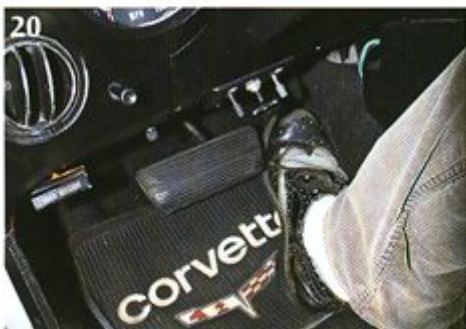
Pat's final underhood check again required a helper. He pulled the aircleaner off and, after looking at the carb for leaks or staining, had me mash the pedal to the floor (*photo 20*) with the engine off as he watched. He was checking to see that the butterflies were fully opening—which they weren't. The primaries were barely reaching half-throttle, in fact, and the secondaries were not even moving. This could require a simple adjustment to fix, or mean a reworking of the entire linkage system. It's also a good idea to verify that a nicely atomized shot of fuel gets delivered as you manually snap open the throttle linkage.

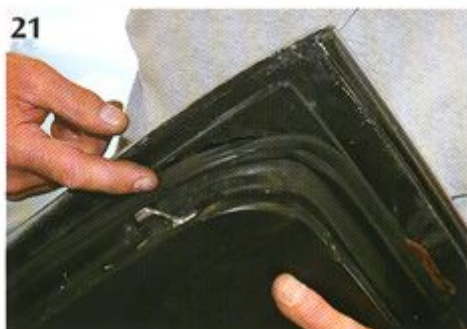
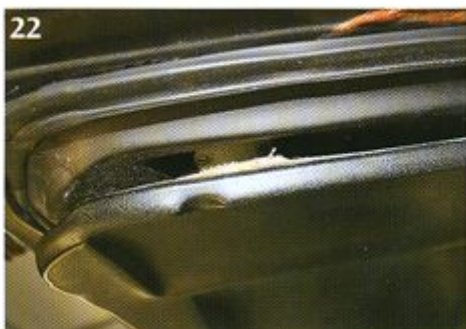
**Q:** Before getting deep into the interior, Pat popped off the T-tops to check their weather seals and headliners. "Two things happen to these: The weatherstrips get folded over on the inside lip (photo 21), and the headliners get loose and start hanging down (photo 22)." Droopy headliners are difficult to set right, and as long as they don't bug the driver they're best left alone. A damaged weatherstrip, on the other hand, is easy to repair and can lead to costly leaks. (Sometimes, you can get the rubber to shift back into the proper location by putting the T-top back on while using a thin piece of cardboard as sort of shoe-horn. After the T-top is locked in, just slip out the cardboard and go.) Some of the most expensive C3

repairs involve rust in the substructures of the windshield and greenhouse. Leaky T-top seals are one of the biggest causes of that condition, so a thorough inspection of both the seals and the steel parts below is a must.

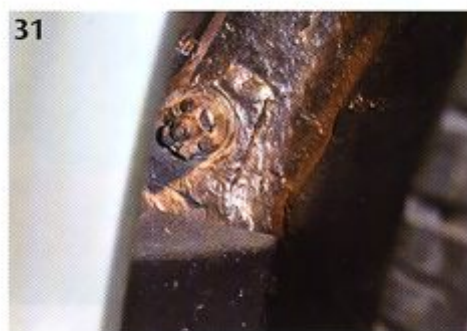
side yokes from sliding off, and a lot of side load passes through these attachments. There are two different styles, a heavy-duty yoke threaded for a bolt and cap (photo 30), and a standard yoke with a strap and a nut. This car had the heavy version, which was a common upgrade in the 1970s. ("I don't want to say the standard ones weren't heat-treated properly at the factory," Pat offered, "but the ends certainly tended to wear off. From about '76 to '79 we did hundreds of rear ends.") If this assembly becomes worn you can feel play at the rear wheel—it's easy to mistake this for a bad wheel bearing. Also make sure to look at the cotter pins on the trailing-arm bolts; our '72 was missing one (photo 31).

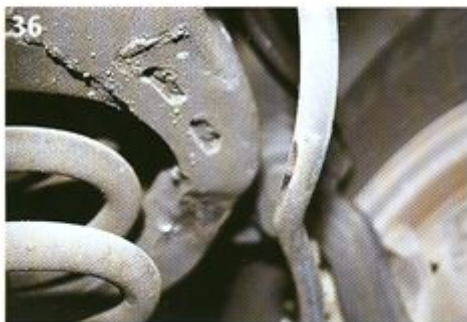
Up front, Pat looked to see if the soft lines were properly oriented and not scraping the frame. Sure enough, he found that the right-front line was twisted and had rubbed the paint off in one area. The same problem had abraded a fair amount of the rubber off the line (photo 36). After that, eyeballing the pads and rotors revealed no worrying issues; neither did grabbing the front wheels and shaking them to assess the bearings (photo 37). Pat then spun each tire in turn to reveal cupping, wobbling, or other signs of trouble. He also felt across the tread of each tire; when I asked him why, he explained that if the surface feels rougher in one direction than the other, it's often a sign of improper toe.
