## Looking for Mr. Goodcar

What do experienced eyes look at during a pre-purchase inspection?  
Jeff Glenn learns how the pros do the job on an early C3.

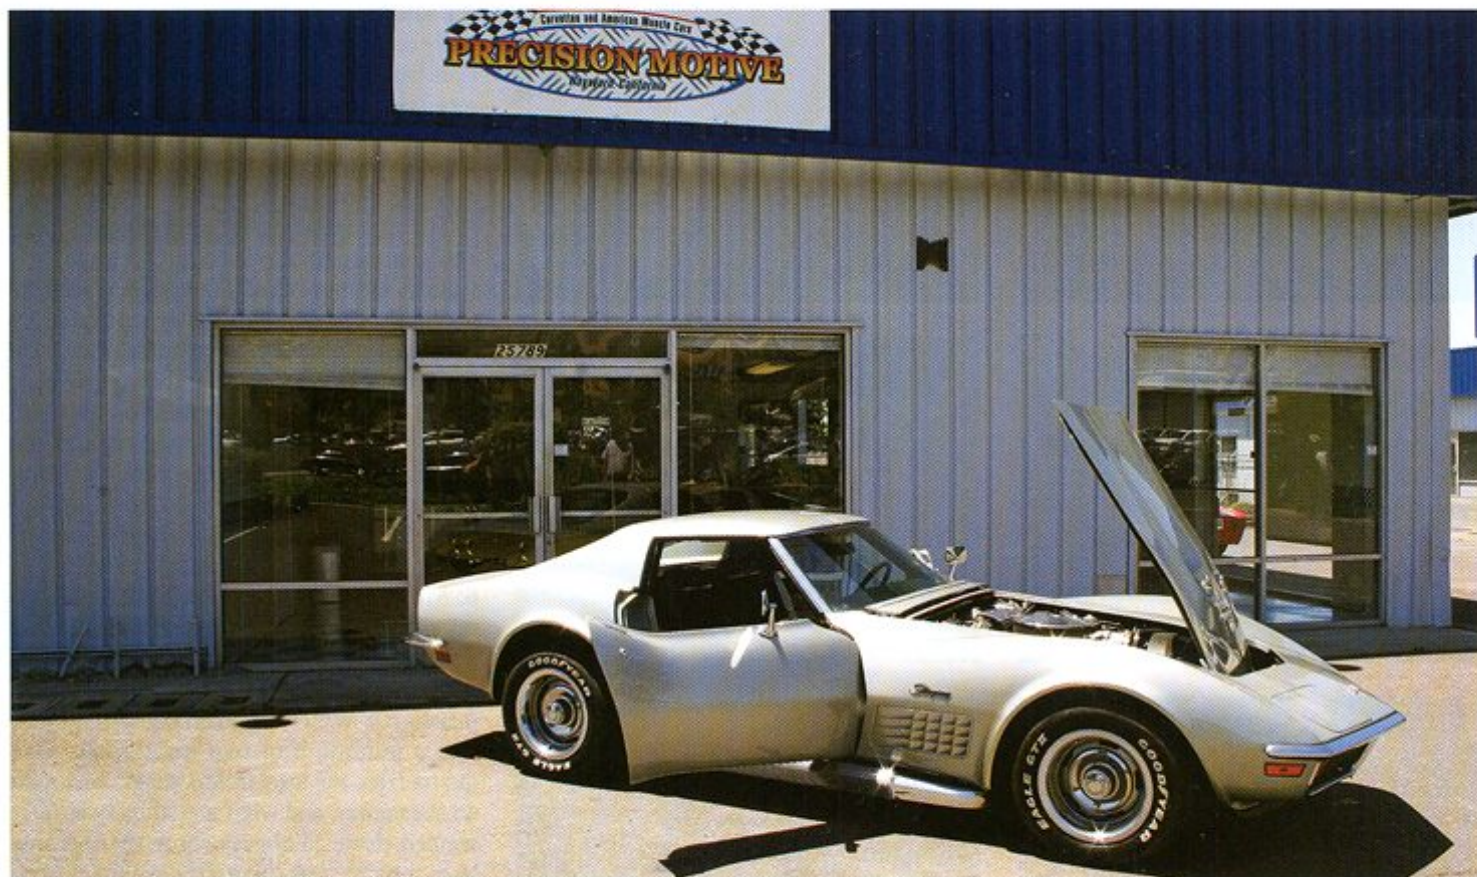
The car we'll be working with is an early C3, but a lot of these concepts transcend generations. Pat Hendrix, CM's faithful consultant from Precision Motive in Hayward, California, took some time off to guide me down the same comprehensive checklist that he uses when asked to inspect one of these cars in his own Corvette shop (*photo 1*).

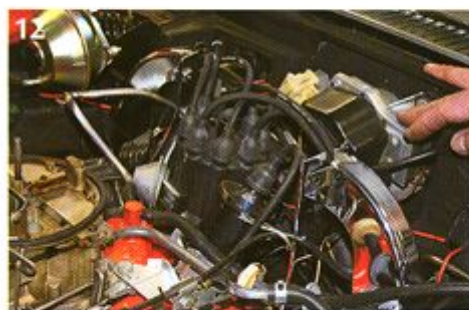
**J:** After running the engine for about a minute, he had me shut it off and then pulled the coil wire from the distributor, carefully putting the loose end down near some grounded metal to give the spark someplace to go (*photo 12*). The next step was to crank the engine a few times and carefully listen to the pattern. A steady, even, rhythmic sound is what you're hoping for. A regular hitch in the sequence or a pattern that continually changes its speed or its pitch means you'd better pull out the gauge and the sparkplug wrench.

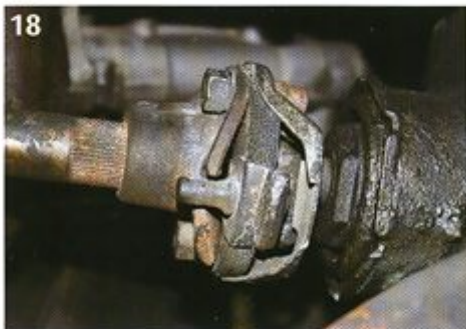
**N:** At the steering column, Pat inspected the coupler (also called a rag joint) while I turned the wheel back and forth (*photo 18*). There should be no cracks and virtually no relative motion. Then he turned the wheel from side to side by himself, feeling for on-center play and listening for funny noises. Play and/or creaks and clunks may indicate linkage problems or other worn steering hardware.

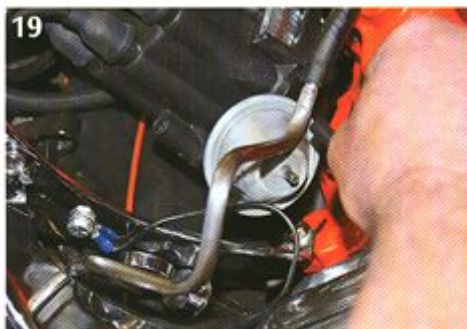
even, not scored, misaligned, or burned. "I like to feel the centrifugal advance and throw a timing light on it to see where that is, too," Pat added. After that, he reinstalled the wires, restarted the car, and pulled the vacuum line off the distributor (*photo 19*). If the idle doesn't change when you do this, the vacuum-advance hardware probably isn't working.

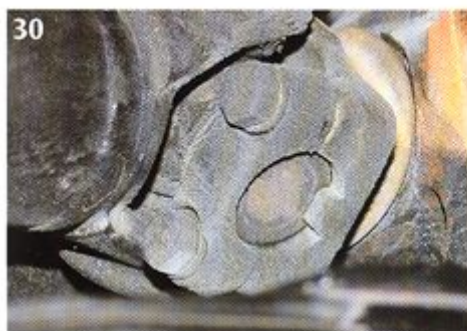
side yokes from sliding off, and a lot of side load passes through these attachments. There are two different styles, a heavy-duty yoke threaded for a bolt and cap (photo 30), and a standard yoke with a strap and a nut. This car had the heavy version, which was a common upgrade in the 1970s. ("I don't want to say the standard ones weren't heat-treated properly at the factory," Pat offered, "but the ends certainly tended to wear off. From about '76 to '79 we did hundreds of rear ends.") If this assembly becomes worn you can feel play at the rear wheel—it's easy to mistake this for a bad wheel bearing. Also make sure to look at the cotter pins on the trailing-arm bolts; our '72 was missing one (photo 31).
